Multiplex Integration Schematic

2019 Allegro Bus

2019 Tiffin Bus General Component Locations Diagram

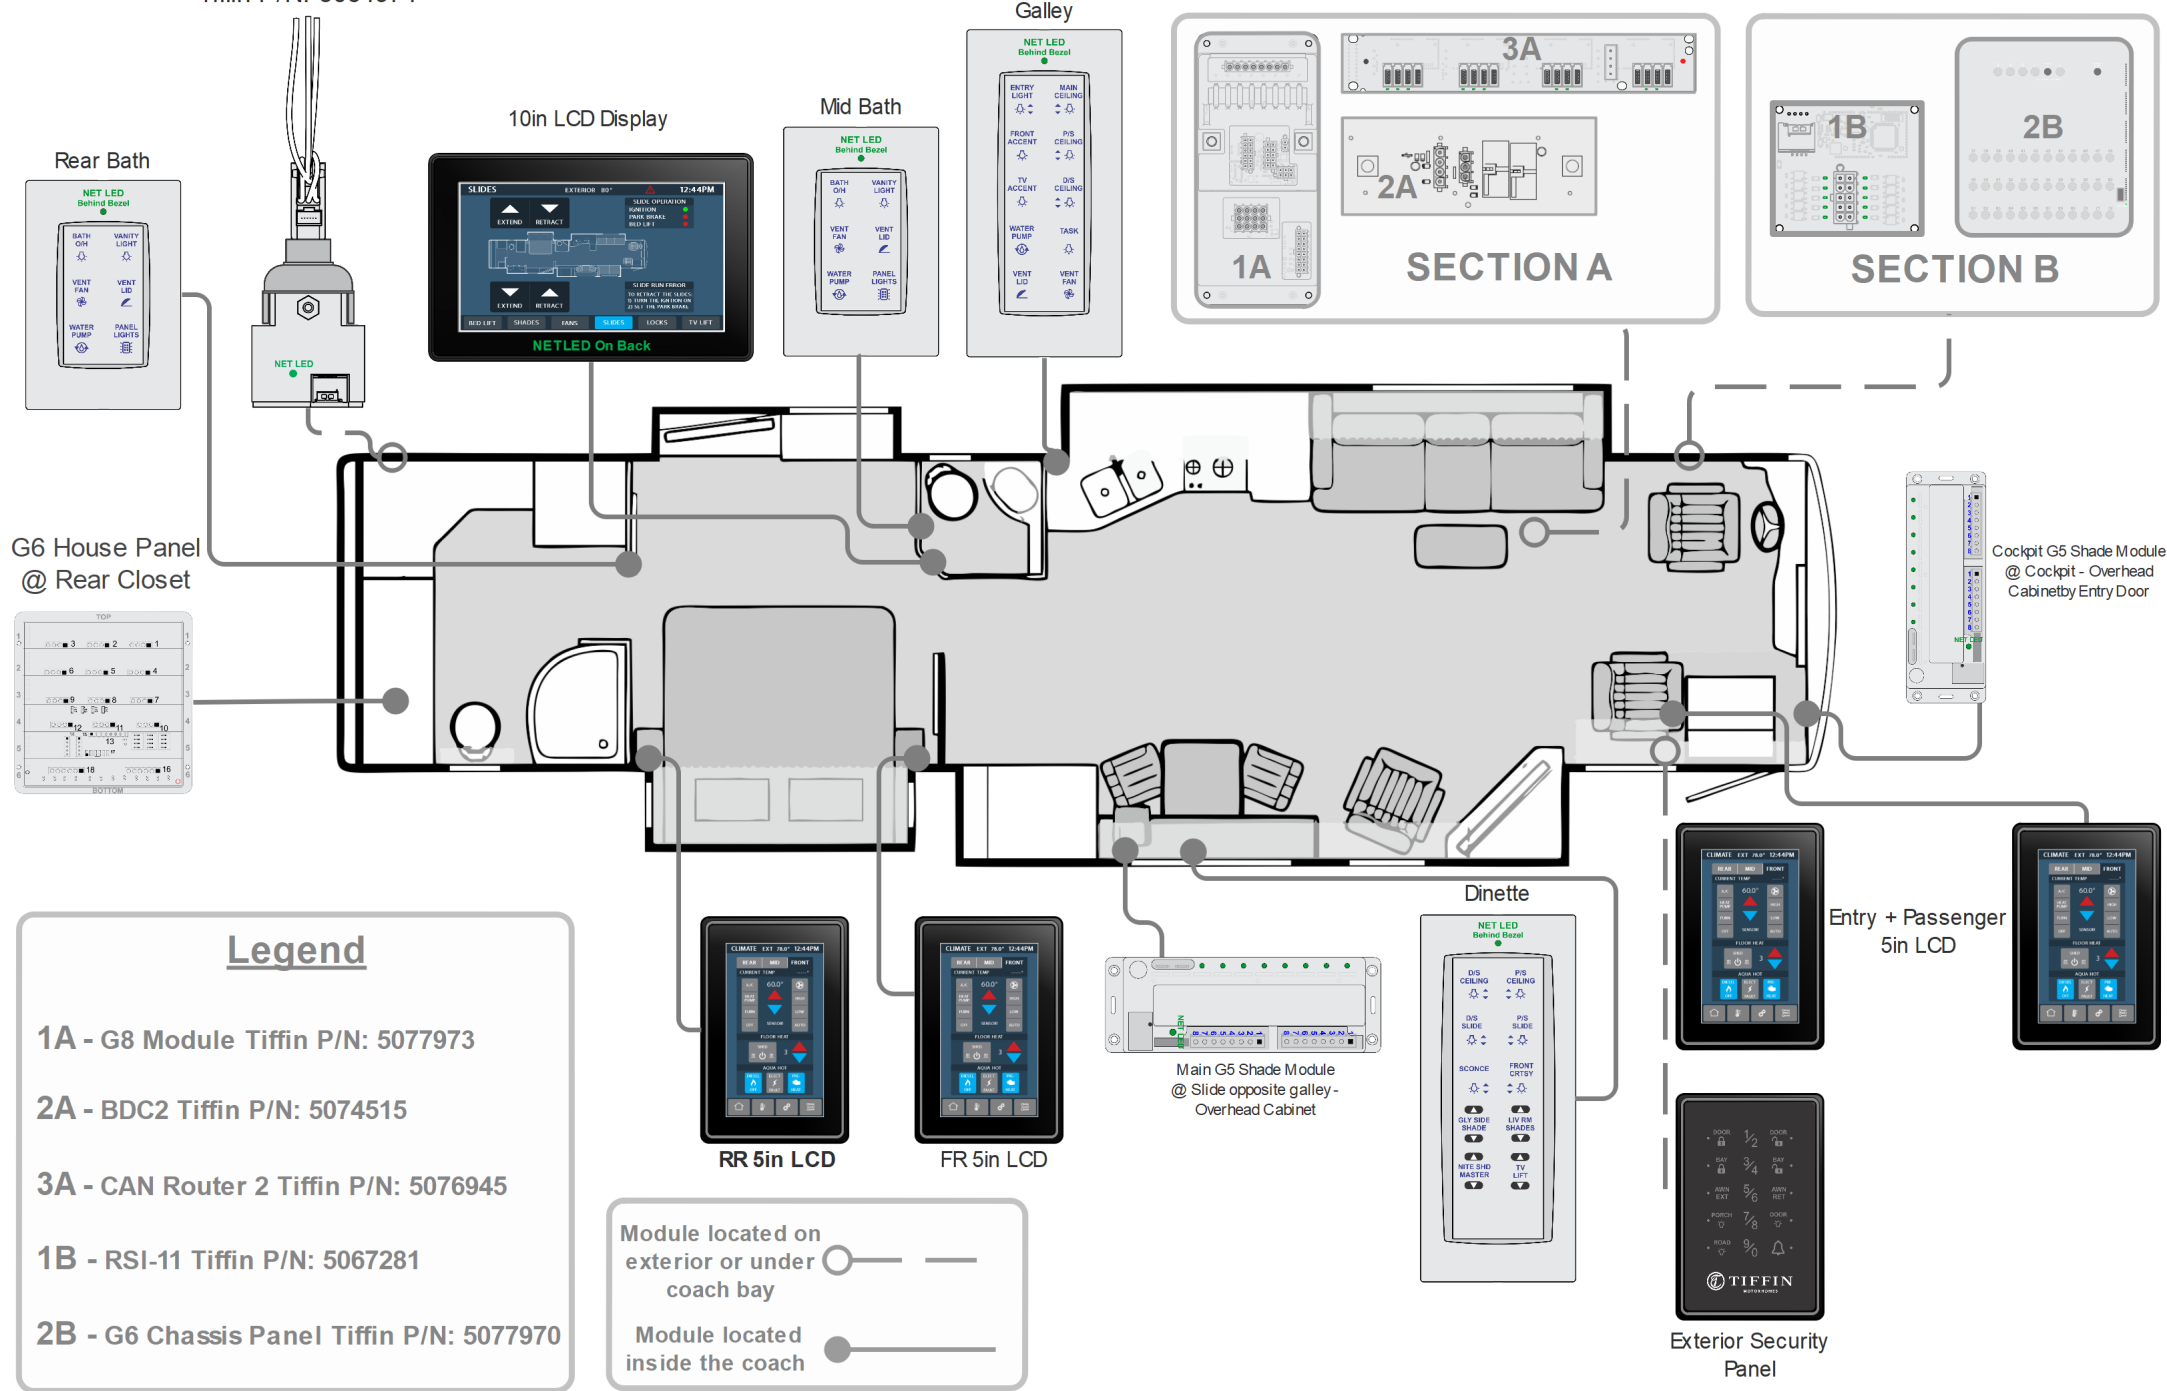
AC Power Monitor
@ Transfer Switch
Tiffin P/N: 5064974

- 1A - G8 Module Tiffin P/N: 5077973
- 2A - BDC2 Tiffin P/N: 5074515
- 3A - CAN Router 2 Tiffin P/N: 5076945
- 1B - RSI-11 Tiffin P/N: 5067281
- 2B - G6 Chassis Panel Tiffin P/N: 5077970

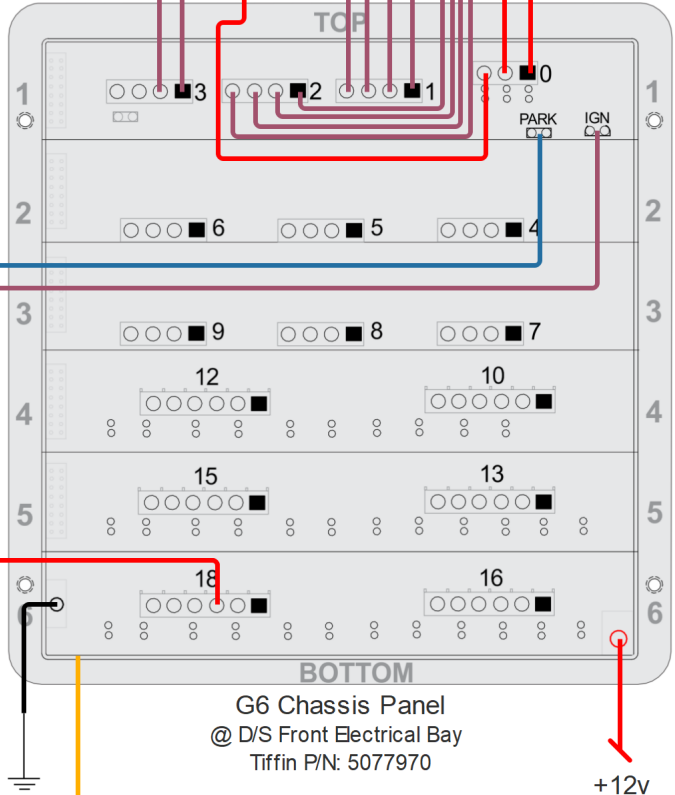
Ignition Switch

P/S Front Slide Switch

D/S Front Slide Switch

Park brake and ignition must be on for slides to operate.
 In case of a system failure, use manual overrides on front of G6 Chassis panel to operate slides.
 Engage overrides using a pen or other pointed object.
